The case study of a brittle failure of a mountain bike frame composed by carbon fiber reinforced plastic

Abstract

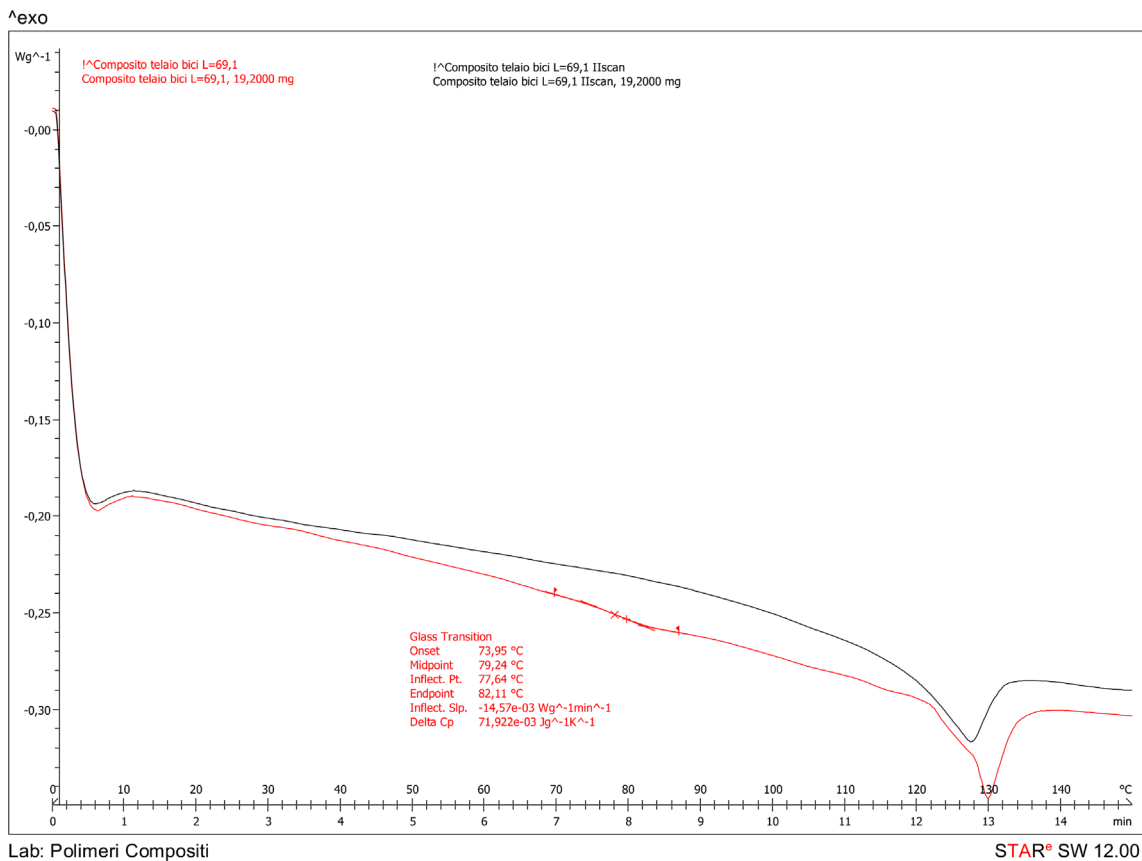
FIGURE 2 Differential scanning calorimetry thermograms of first and second heating scans.

From the DSC thermograms, it can be concluded that the resin in the composite material is fully cured with a glass transition temperature of about 78°C. The melting

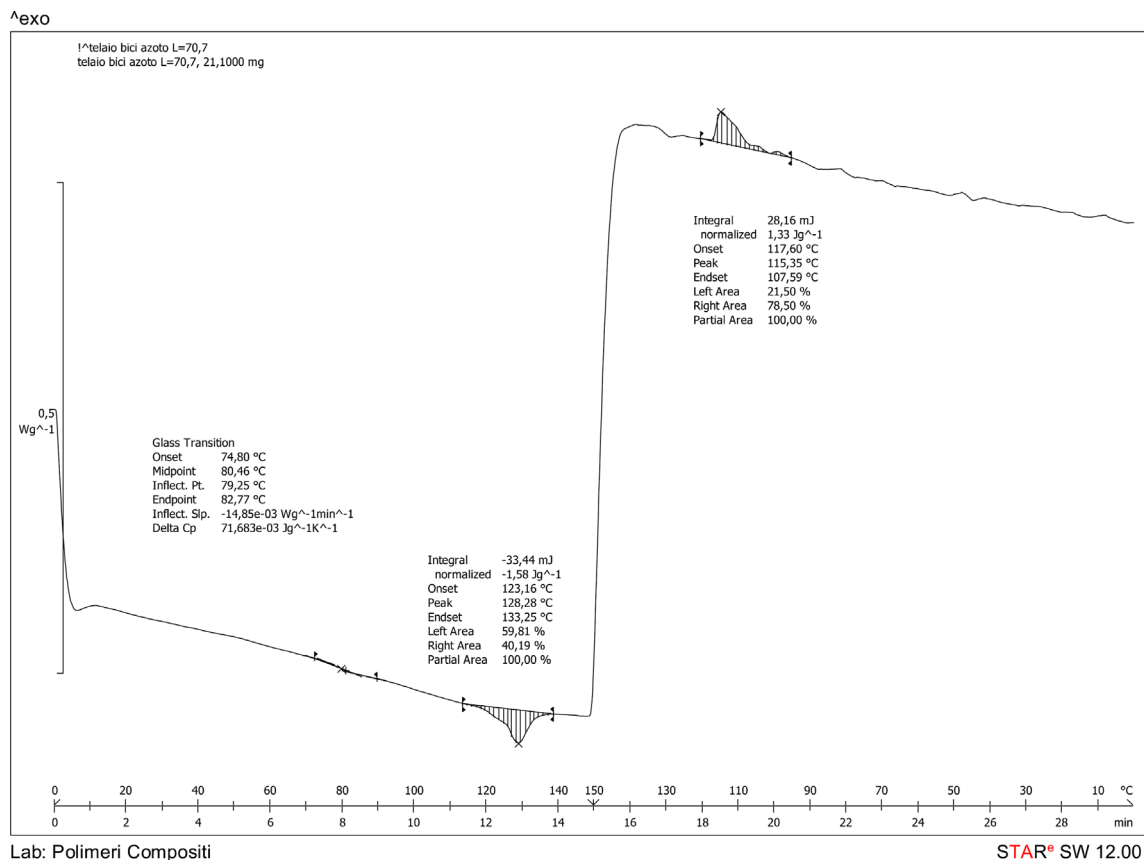
FIGURE 3 Differential scanning calorimetry thermograms of third heating cooling scans.

peak located at about 130°C can be attributed to a thermoplastic material (probably polyethylene). In fact, even by naked eyes inspection, some white fibers can be noticed. This additional phase will be discussed in the next sections. A third DSC scan followed by a cooling scan confirmed that the signal is related to a crystallization process of a thermoplastic polymer, Figure 3.

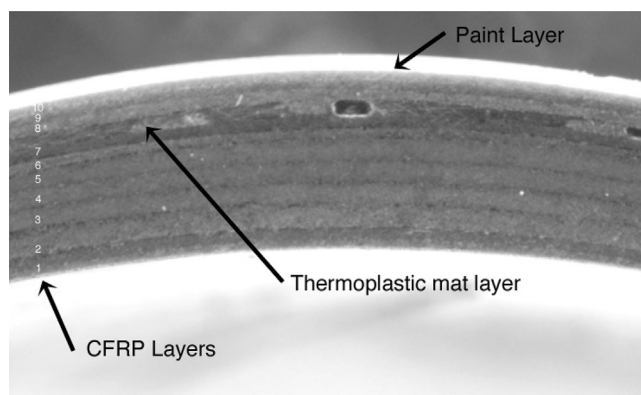
FIGURE 4 Cross section of composite showing well typical cross-section profile in top tube.

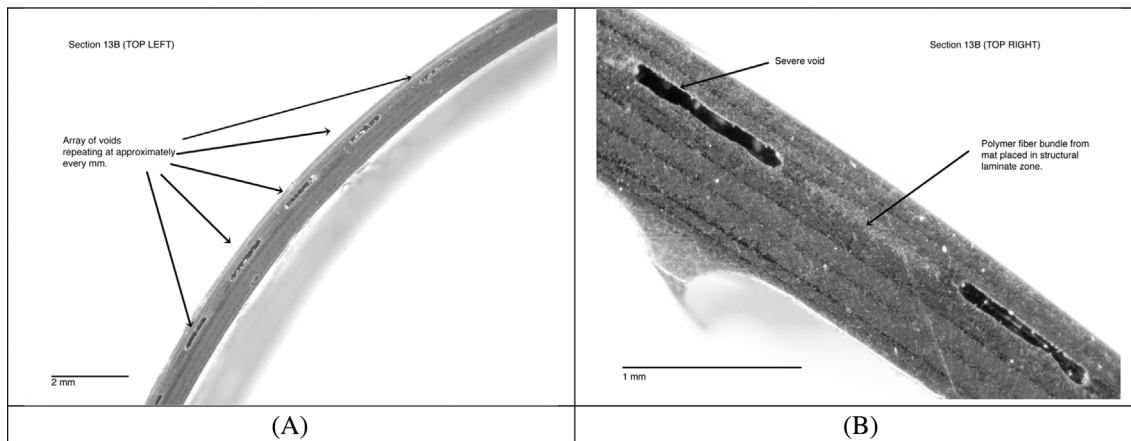
FIGURE 8 (A) Large voids corresponding to the gaps in the polymer fiber mat. (B) Close-up showing large voids occurring after several layers from the outer surface in the region corresponding to the thermoplastic fiber mat.

The thermoplastic fiber mat is problematic for several reasons. The mat is located a few CFRP plies from the outer surface of the composite. Thus the mat is sandwiched between structural layers and thus cannot be considered a non-structural part such as the paint or primer layer. In addition, the mat used has large gaps (greater than 1 mm), which coupled with improper compaction during cure (e.g., low pressure areas) results in large voids forming within these regions (as seen in Figure 8A,B). Note the ordered location of voids in this layer corresponding to the gaps in the mat layer. The defects are so numerous and close to each other that their interaction is expected to further weaken this frame.

In the top tube, it is observed that this thermoplastic fiber mat extends from the lower radius to the top radius regions, with the top and bottom surfaces not appearing to contain this mat layer. It is possible that this thermoplastic mat layer may have been added to reinforce this section or improve the processing although without having additional design details this remains only a speculation. It is curious that the tension failure observed in the top tube as a crack running along the top tube main axis (on both sides of the tube) occurs in this region. The curved radius region is a highly stressed region in composite tubular parts. The fracture surface does not show carbon fibers present in the laminate that are perpendicular to the crack. It is not realistic to assume that the thermoplastic mat added around the curves is enough to reinforce this area significantly due to their low volume fraction (due to large spacing). This is also coupled with the fact that the mat seriously compromises the strength and stiffness of the composite laminate in this area by allowing for severe void nucleation sites.

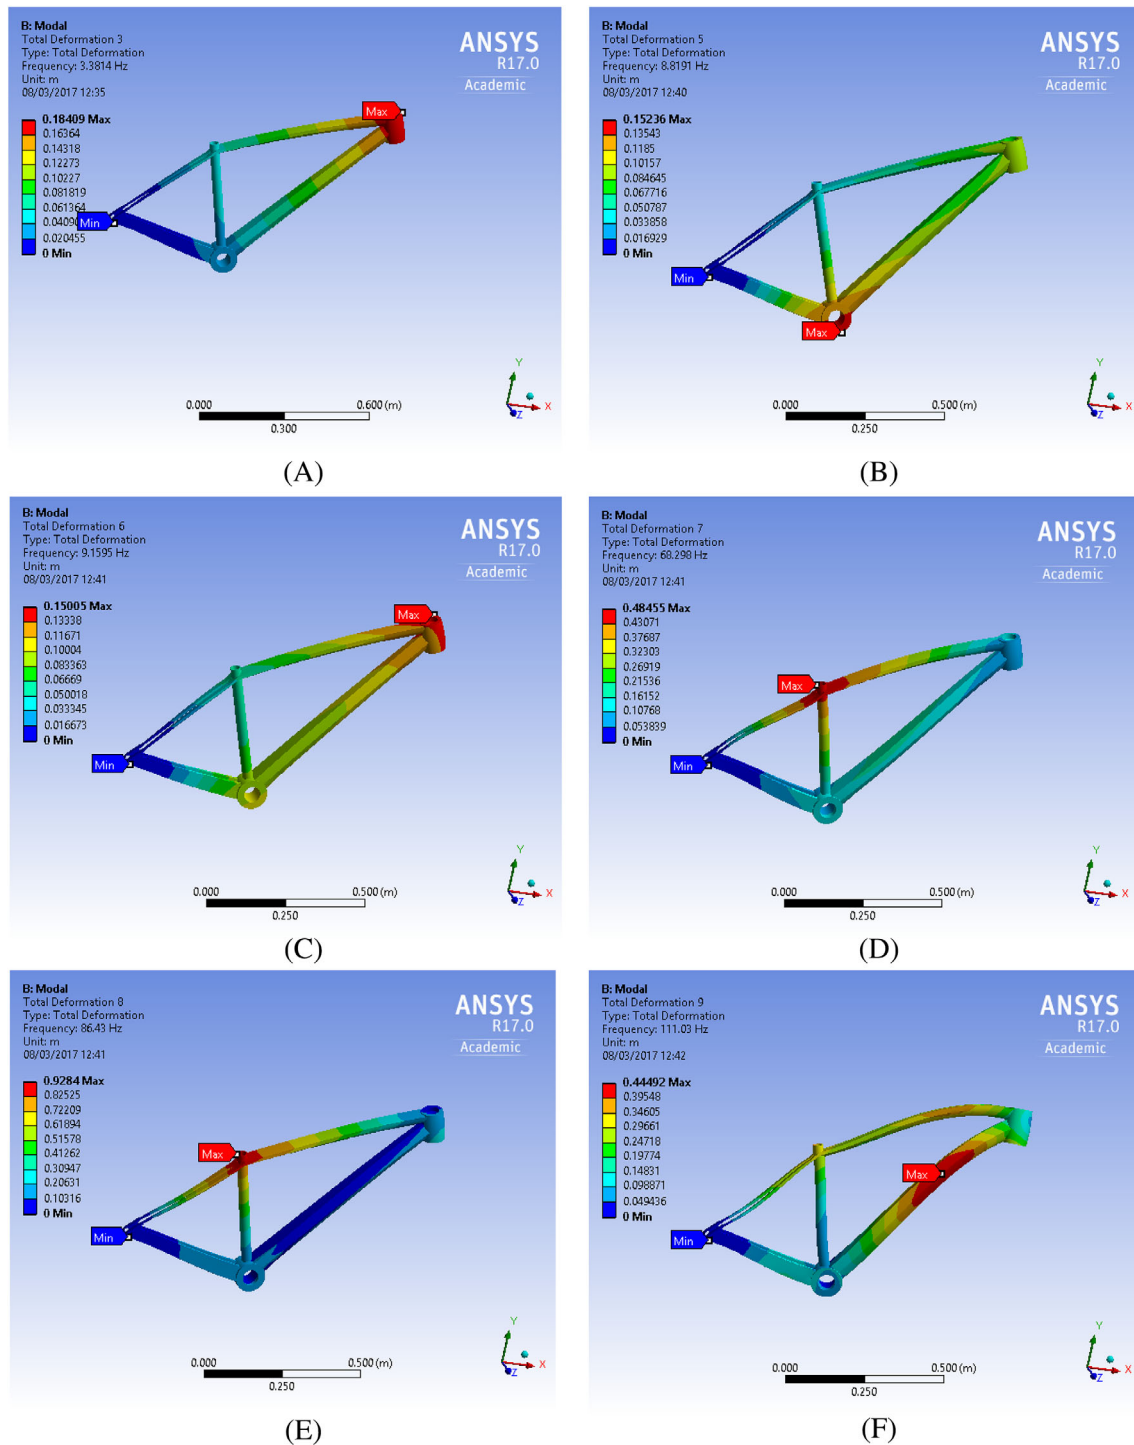
FIGURE 11 (A) Mode 1. (B) Mode 2. (C) Mode 3. (D) Mode 4. (E) Mode 5. (F) Mode 6.

fork is $A = 2.18 \times 10^{-3} \text{ m}^2$ thus as $K_f = K/A$ (Table 8). Figure 10B and Table 9 report the adopted mesh. The computed natural frequencies are reported in Table 10 and, due to the driver position/man mass real distribution and measured low elastic modulus, are observed quite low, from 3 up to 111 Hz for the first 6 modes, Figure 11A–F. Note that mode 4 has a frequency around 68 Hz and is thus compatible with a resonance imposed by the wavy nature of the grass and cycling velocity (previously computed as 69 Hz); also note that the related mode shape (Figure 11D) has the maximal relative displacement in the region of the observed fracture. We cannot thus exclude that the observed severe defects were further weakened by interaction with a dynamic resonance.
