The case study of a brittle failure of a mountain bike frame composed by carbon fiber reinforced plastic

Abstract

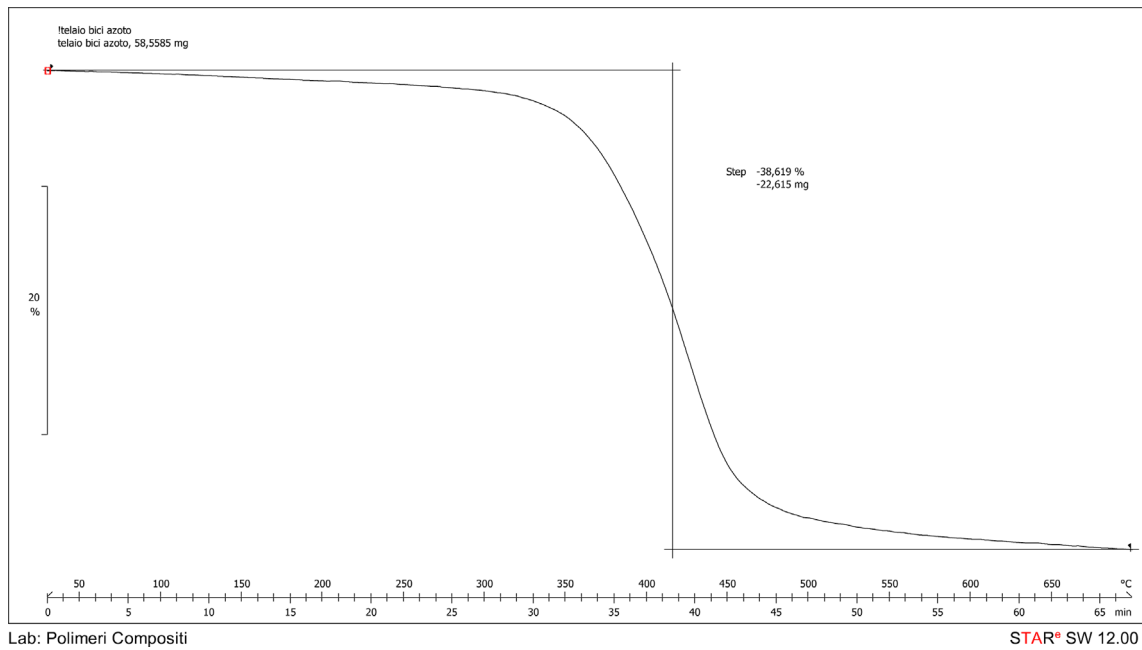
The fiber weight content has been measured by thermogravimetric analysis (TGA) on a small (about 60 mg) sample cut from the bike frame. TGA measurements were performed on a TA Q5000 machine under a nitrogen flux of 100 mL/min at a heating rate of 10°C/min. The obtained thermogram is reported in Figure 1. The observed total weight loss at 700°C is of 38.62%. Therefore the fiber weight fraction can be estimated to be 61.38%.

FIGURE 1 Thermogravimetric analysis thermogram under inert atmosphere.

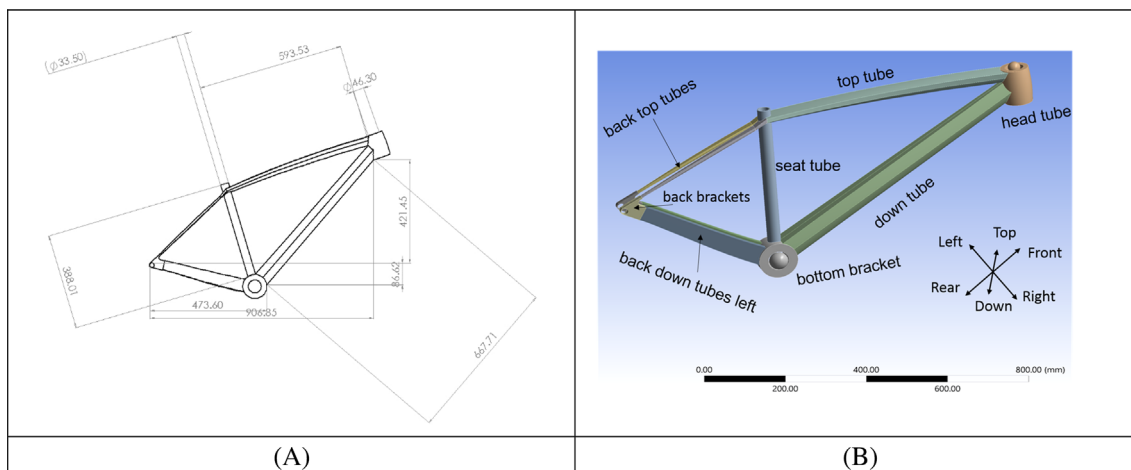
FIGURE 9 (A) Geometries (sizes in mm) considered in the numerical simulations. (B) Adopted nomenclature.

are reported in Figure 9A. For the nomenclature please refer to Figure 9B. Table 3 reports the properties of the single parts. Table 4 reports the measured and thus adopted thicknesses. Figure 10A reports the applied boundary conditions. Table 5 reports the properties of the pointed masses, simulating the driver mainly placed on pedals according to the real case. Table 6 reports the volume and mass of the simulated system. Table 7 reports

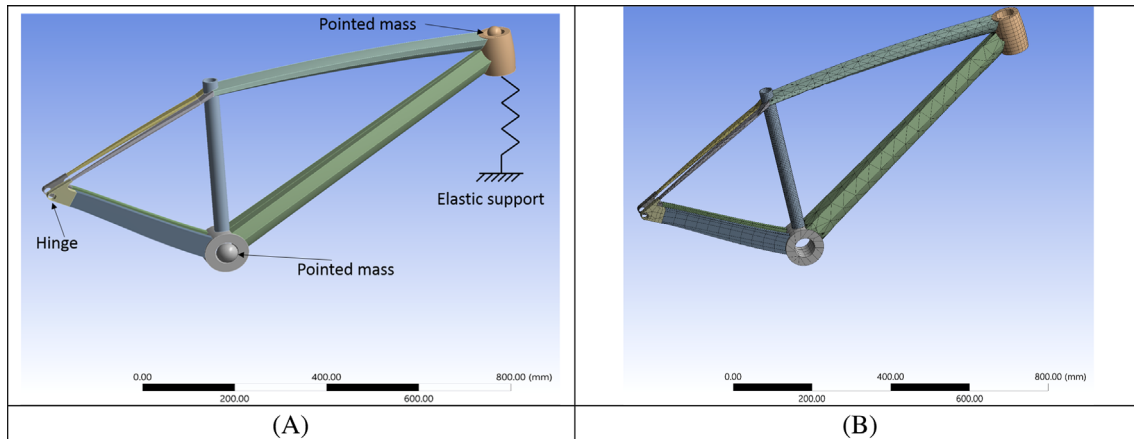
**FIGURE 10** (A) Applied boundary conditions. (B) Adopted mesh.**TABLE 5** Properties of the pointed masses.

fork is $A = 2.18 \times 10^{-3} \text{ m}^2$ thus as $K_f = K/A$ (Table 8). Figure 10B and Table 9 report the adopted mesh. The computed natural frequencies are reported in Table 10 and, due to the driver position/man mass real distribution and measured low elastic modulus, are observed quite low, from 3 up to 111 Hz for the first 6 modes, Figure 11A–F. Note that mode 4 has a frequency around 68 Hz and is thus compatible with a resonance imposed by the wavy nature of the grass and cycling velocity (previously computed as 69 Hz); also note that the related mode shape (Figure 11D) has the maximal relative displacement in the region of the observed fracture. We cannot thus exclude that the observed severe defects were further weakened by interaction with a dynamic resonance.
