Experimental analysis of self-healing cement-based materials incorporating extruded cementitious hollow tubes

Journal of Intelligent Material Systems and Structures
2016, Vol. 27(19) 2633–2652
© The Author(s) 2016
Reprints and permissions:
sagepub.co.uk/journalsPermissions.nav
DOI: 10.1177/1045389X16635847
jim.sagepub.com

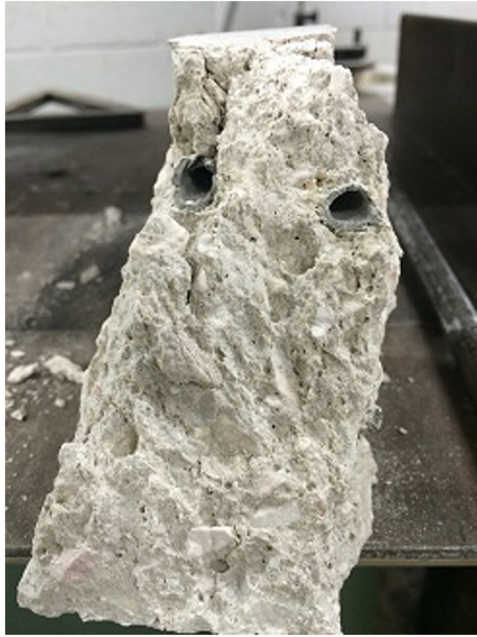
Figure 1. Fragment of the cubic specimen with horizontally oriented hollow tubes after failure in compression: two fractured hollow tubes are visible at the top of the fragment and the good adhesion between the tubes and the cementitious matrix can be noted.

SCC in a proportion of 1.6% in volume does not significantly influence the compressive strength. A minor effect related to the orientation of the CHT with respect to the load direction was observed, as the samples with randomly dispersed CHT showed a small strength decrease on average; such a reduction can be ascribed to the fact that the tubular capsules in this case were incorporated during casting by pressing them into the fresh concrete mix in order to guarantee a random orientation in space and this could have contributed to worsen the interfacial properties between concrete matrix and CHT. However, this variation is less than 10% and can be regarded as negligible, as confirmed by the Standard UNI EN 196-1 *Methods of testing cement—Part 1: Determination of strength*. Moreover, neither slipping nor de-bonding of the tubes was observed at the end of the compressive tests, each tube being perfectly adherent to the concrete matrix even after final failure (Figure 1).

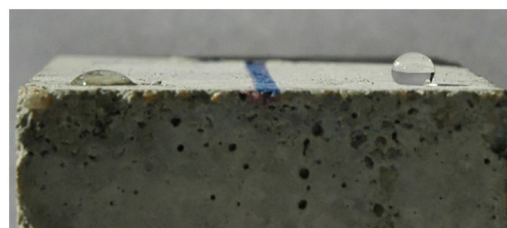
Figure 4. Water drops on a mortar sample: hydrophilic standard mortar surface (on the left side; contact angle roughly estimated to be about 45°) and hydrophobic mortar surface after treatment with a siloxanic hydrophobicizing agent in water solution (contact angle roughly estimated to be about 140°).

To enhance the release of the healing agent along the crack, a hydrophobic coating (Idrosil-acqua, Sinopia, Italy; a siloxanic hydrophobicizing agent in water solution, Figure 4) was applied by immersion to the surfaces of some of the tubes, above the sodium silicate layer, while some other ones were left with no hydrophobicizing coating for the sake of comparison.

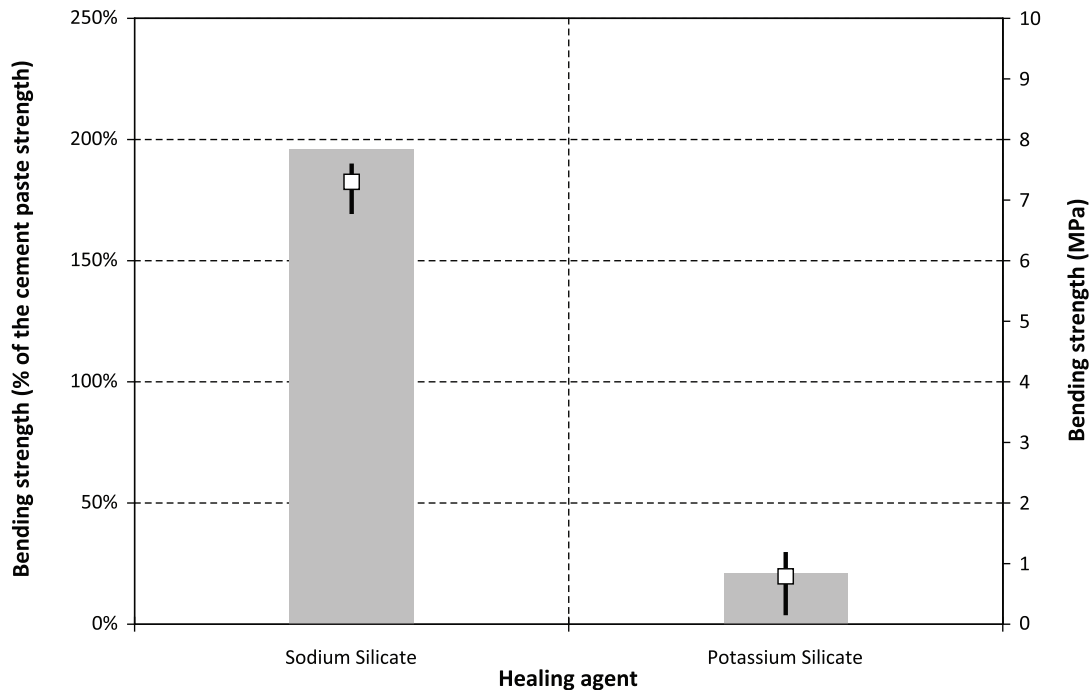
Figure 7. Preventive evaluation of sodium and potassium silicate as healing agents: white squares indicate the average bending strengths obtained on the samples reassembled using sodium or potassium silicate as a healing agent (values to be read on the right vertical axis); upper and lower edges of the solid black lines indicate, respectively, the maximum and the minimum values of the bending strengths obtained on the same samples (values to be read on the right vertical axis); gray bars indicate the average bending strengths obtained on the same samples as a percentage with respect to the initial cement paste strength (values to be read on the left vertical axis).

obtained with the selected healing agents. In fact, all the samples reassembled with sodium silicate displayed a higher bending strength than the intact specimens, nearly double on average (Figure 7). On the contrary, the samples reassembled using the potassium silicate solution reached only slightly more than 20% of the bending strength of the intact specimens. These different behaviors could be ascribed to its lower viscosity: it is possible that the inorganic resin was partially absorbed into the matrix decreasing the amount of the liquid available for crack filling and repairing.

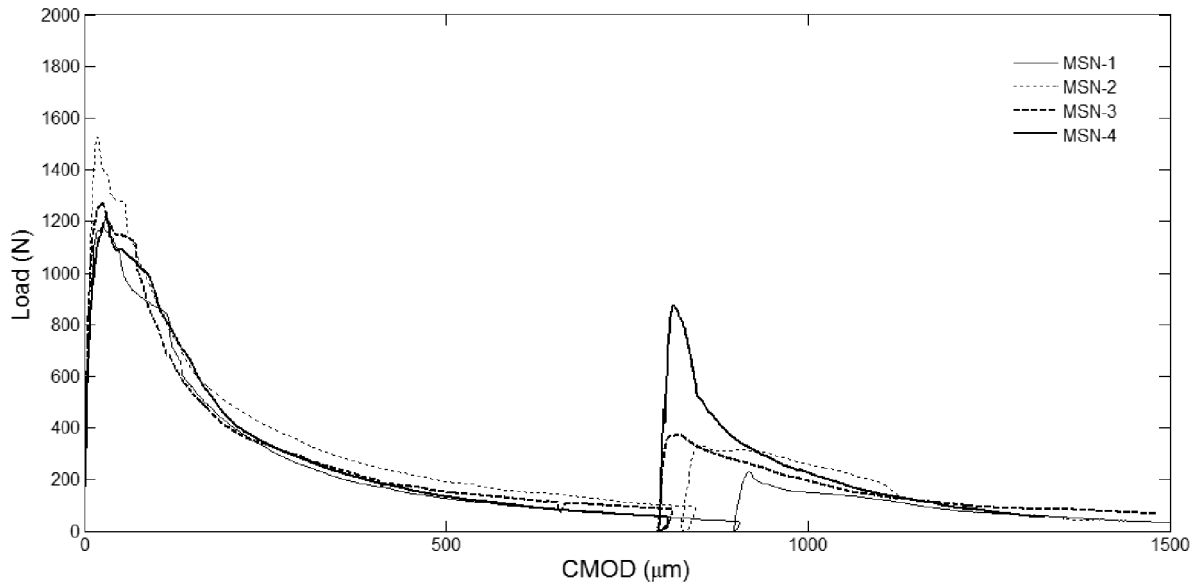
Figure 11. Load versus CMOD curves for self-healing specimens belonging to the MSN series, as resulting from pre-loading and re-loading stages.

Evaluation of the self-healing effect. The results of the three-point bending tests performed for the evaluation of the self-healing effect are reported in Figures 10 to 14 and in Figures 15 and 16, respectively, in terms of load versus CMOD curves and in terms of average LRI and SRI—both for early-age pre-loading and actualized, in accordance with equations (1), (2), (3), and (5). From these graphs, it is immediately evident that the proposed self-healing system as a whole is definitely effective. Indeed, the control specimens presented LRIs that ranged approximately from +0.9% to +2% (correspondingly, the ALRIs ranged from 0.7% to 1.6%) and SRIs (either actualized or not) that never exceeded

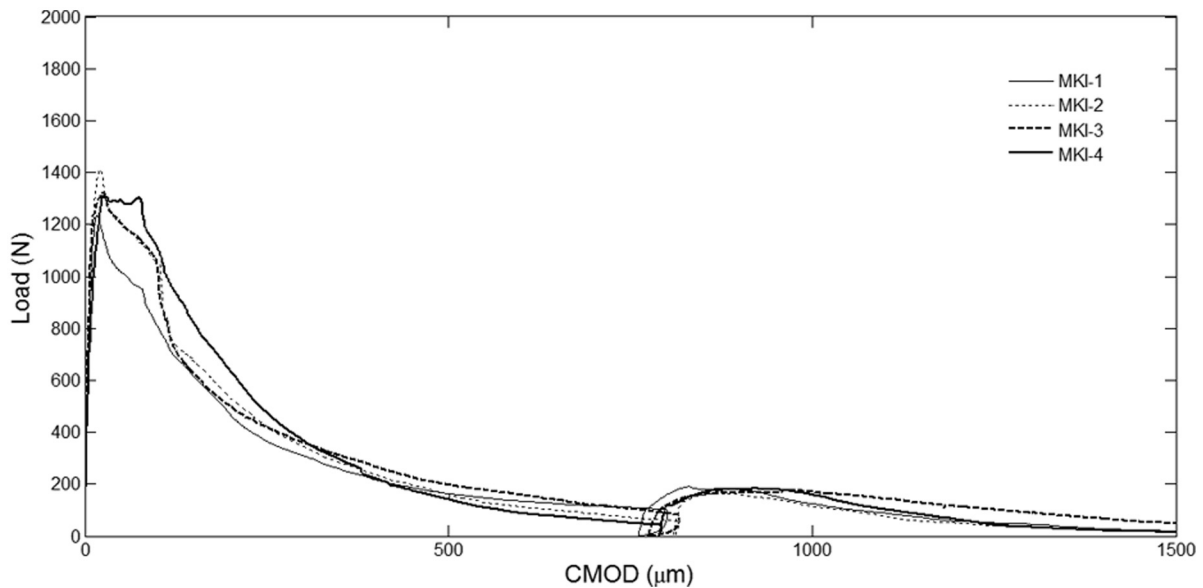
Figure 12. Load versus CMOD curves for self-healing specimens belonging to the MKI series, as resulting from pre-loading and re-loading stages.
